**Tilcon New Jersey
Pompton Lakes Quarry
Quarterly Blast Compliance Summary
2nd Quarter 2018**

Comparison of Measured Blast Vibrations to Current U.S. Bureau of Mines Recommendations Tilcon New Jersey Pompton Lakes Quarry 2nd Quarter 2018

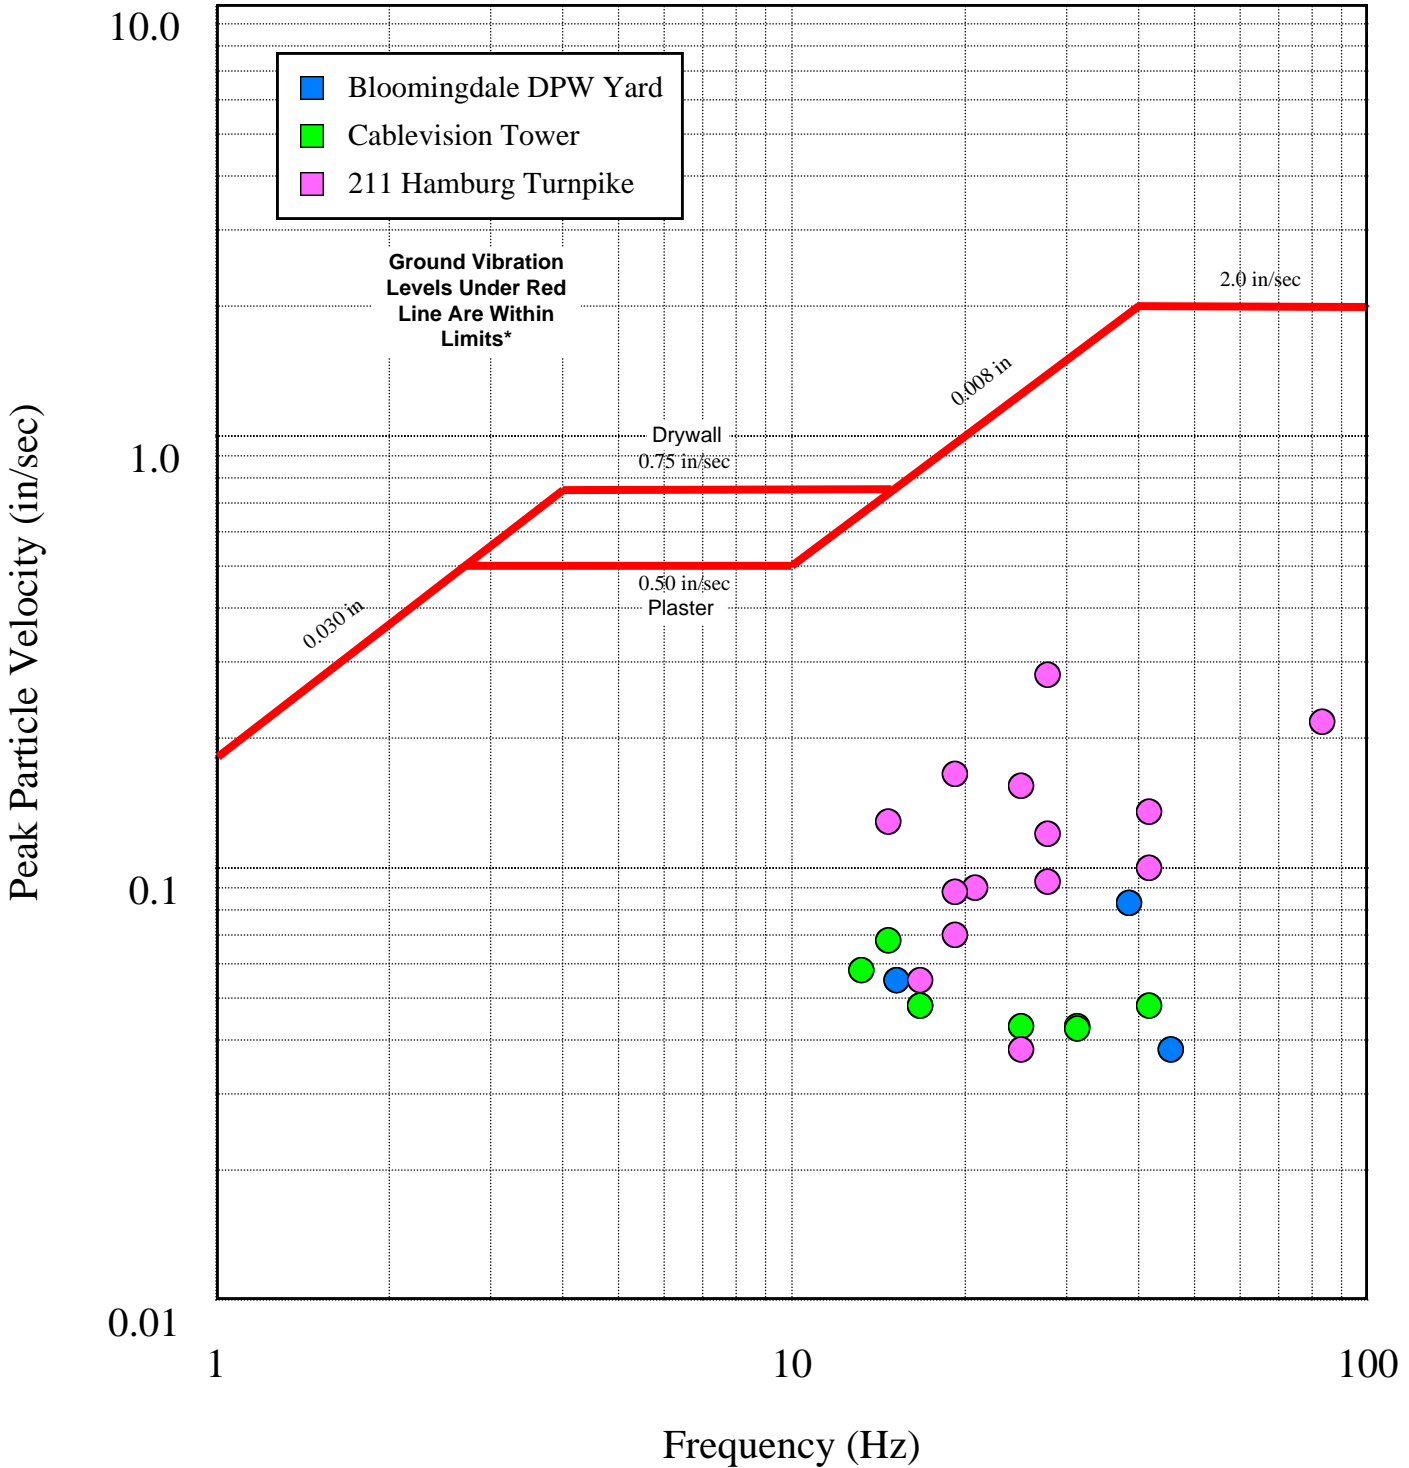
*As per State of New Jersey Administrative Code Title 12:190; Subchapter 7.26

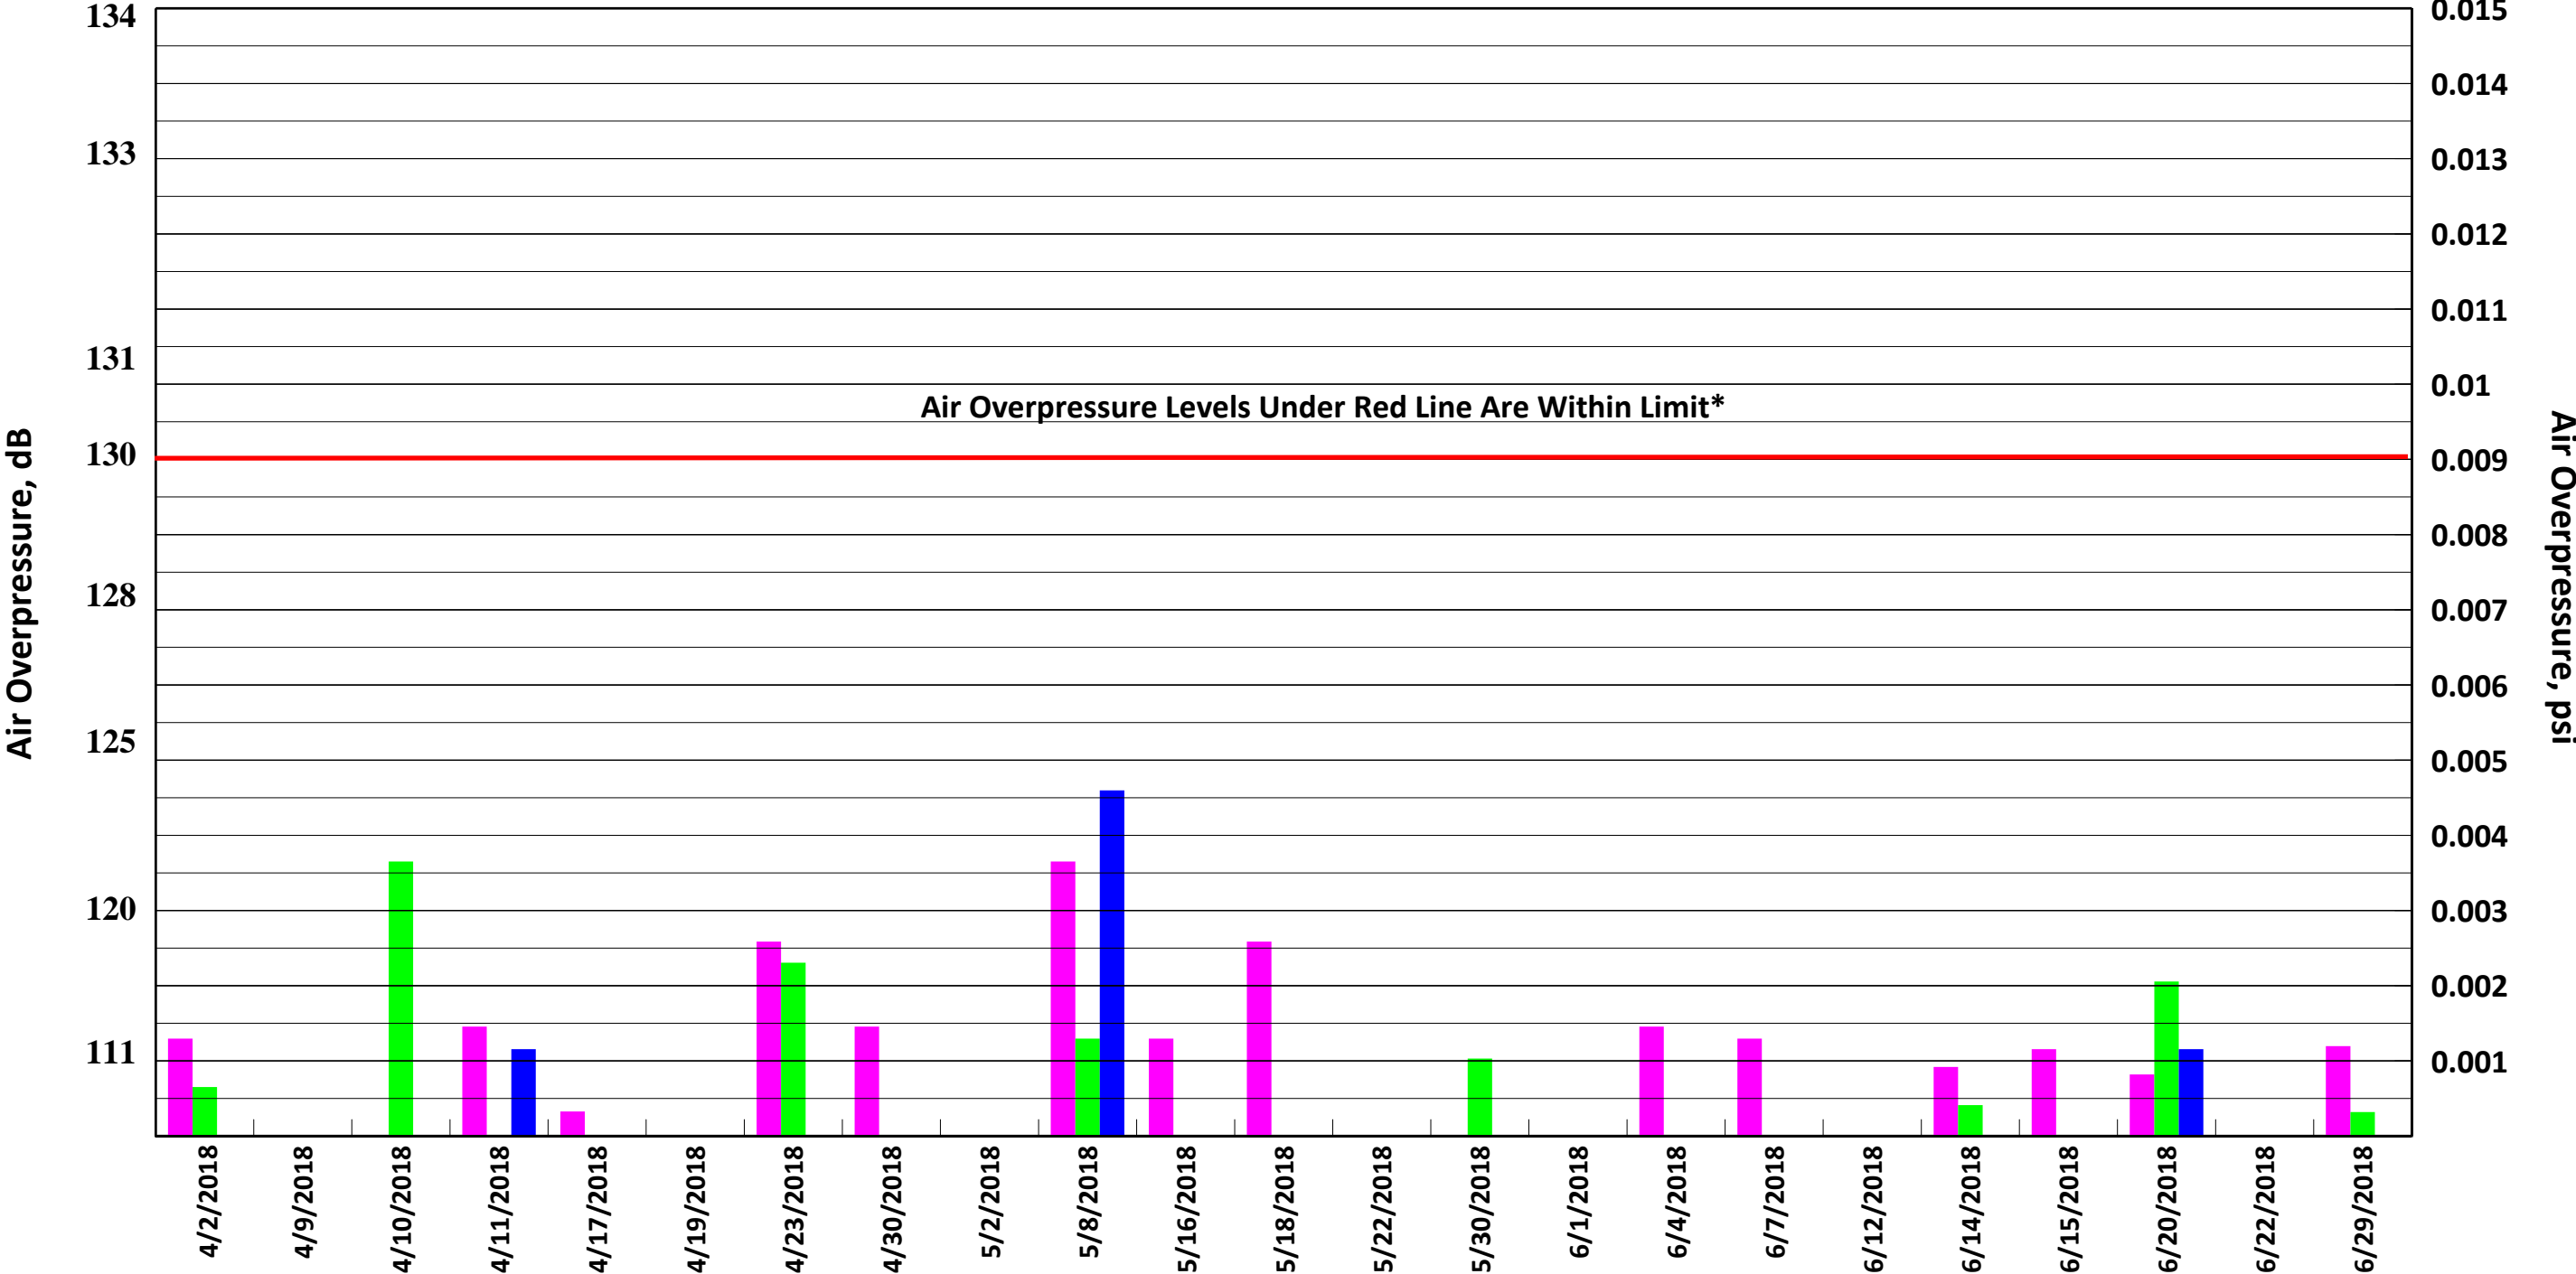
Air Overpressure Levels from Tilcon New Jersey - Pompton Lakes Quarry 2nd Quarter 2018

*As per State of New Jersey Administrative Code Title 12.190; Subchapter 7.25

■ 211 Hamburg Turnpike
 ■ Cablevision Tower
 ■ Bloomingdale DPW Yard
